# Technical Service Information

## BMW - A4S (THM 4L30-E) DIAGNOSTIC TROUBLE CODE 40 (Pressure Control Solenoid Circuit)

*Adapted from BMW's Service Bulletin 24 06 94*

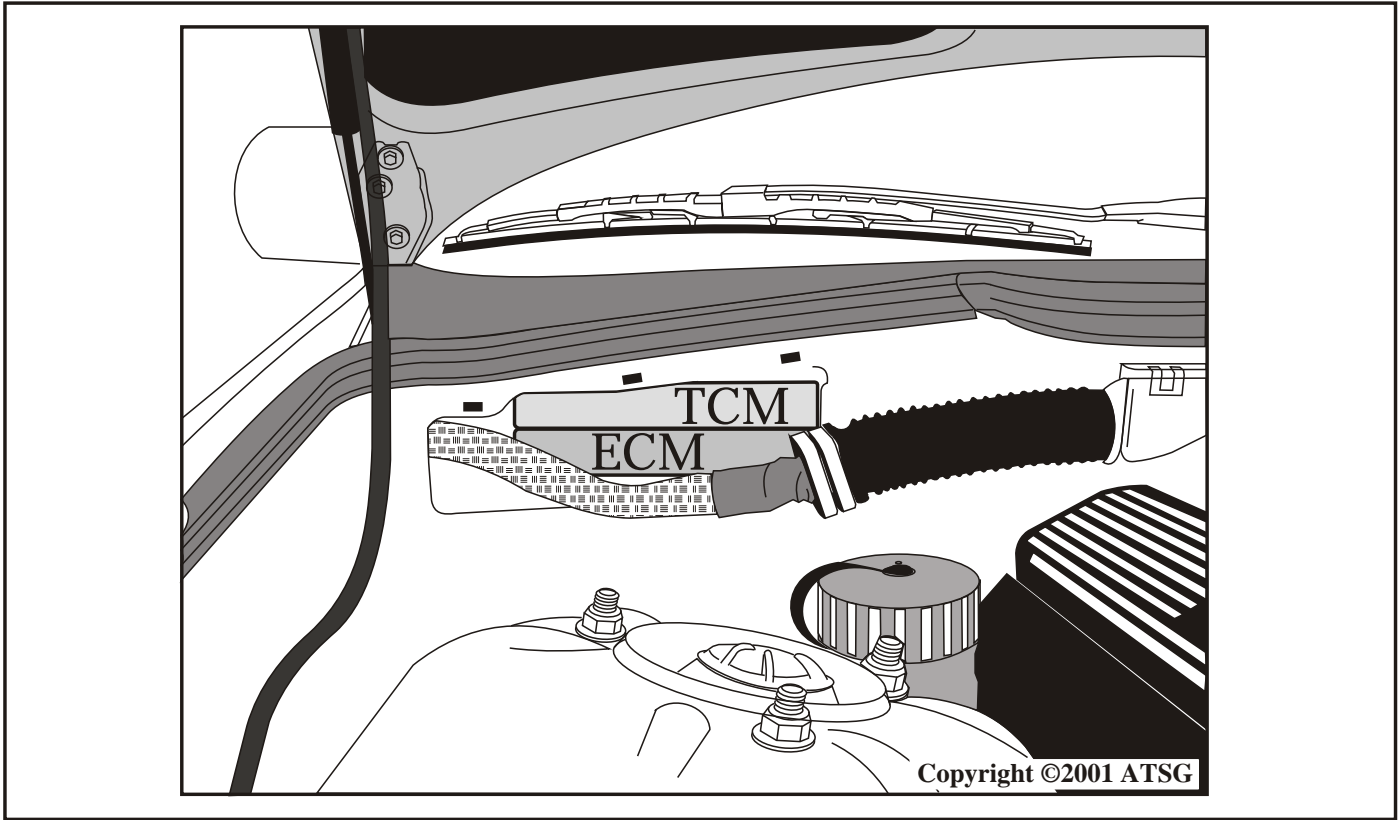
Figure 1

- a. 1992 to 1995 318i & 325i vehicles, the unit can be found in the passenger side engine compartment behind a cover plate as seen in Figure 1.
- b. 1991 to 1993 525i vehicles, the unit is behind the passenger side kick panel.
- c. 1994 to 1995 525i vehicles, it is the middle unit located in an electrical box in the engine compartment front of passenger side firewall.

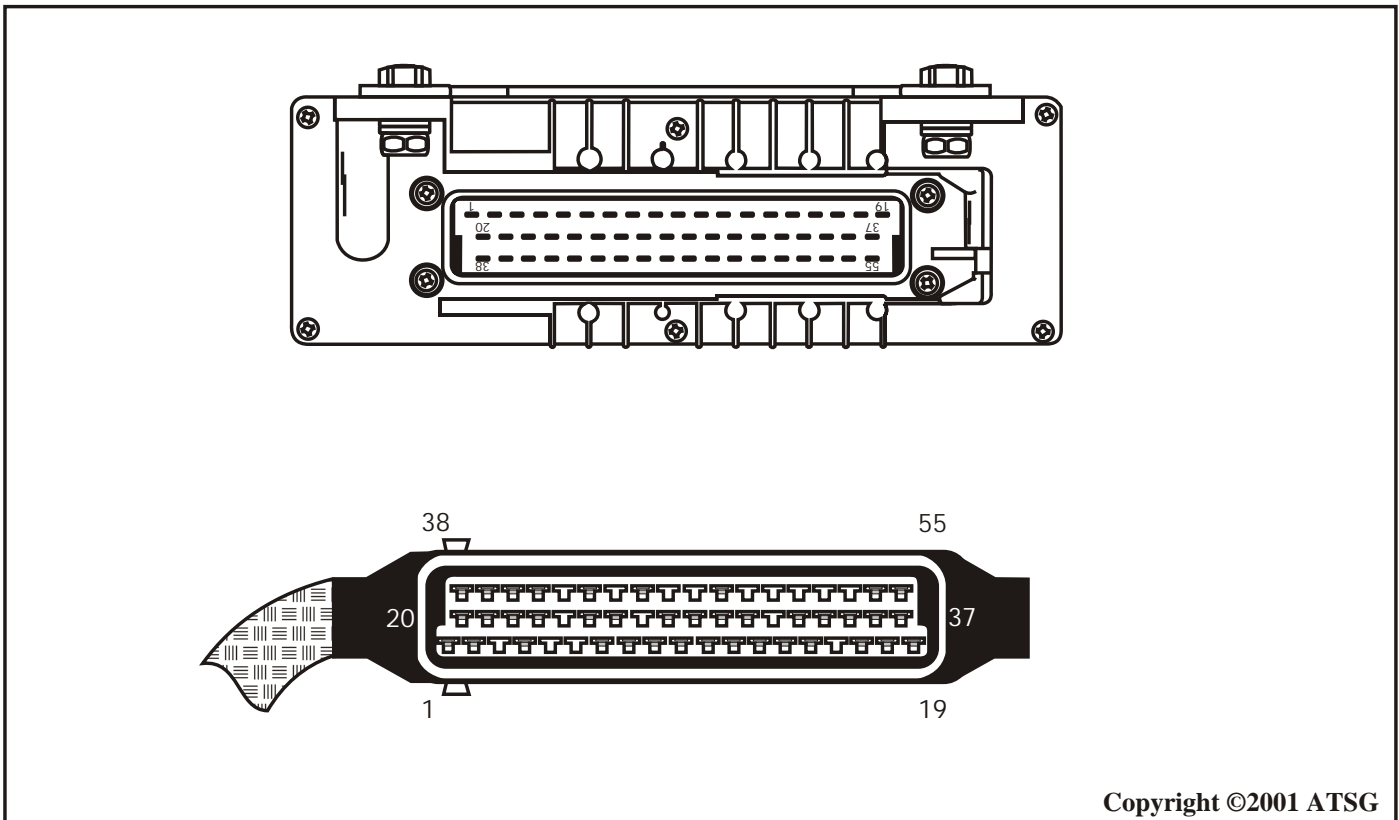
Figure 2

Once the TCM is located, unplug the 55 pin connector and identify pin locations using Figure 2. With the ignition OFF and a DVOM set to ohms, check the ground circuit for continuity from terminal 19 in the vehicle harness connector to ground. If continuity is not observed, provide a permanent ground for wire 19. To ensure that a good ground exists, plug the harness back into the TCM. Start up the vehicle and turn on as many electrical loads as possible. Switching your DVOM to DC volts, place the negative lead to ground and probe wire 19 with the positive lead. Less than 0.3 volts should be observed. Repair ground wire as necessary. Once the ground wire check is acceptable and code 40 persists, perform the following excessive voltage check procedure.

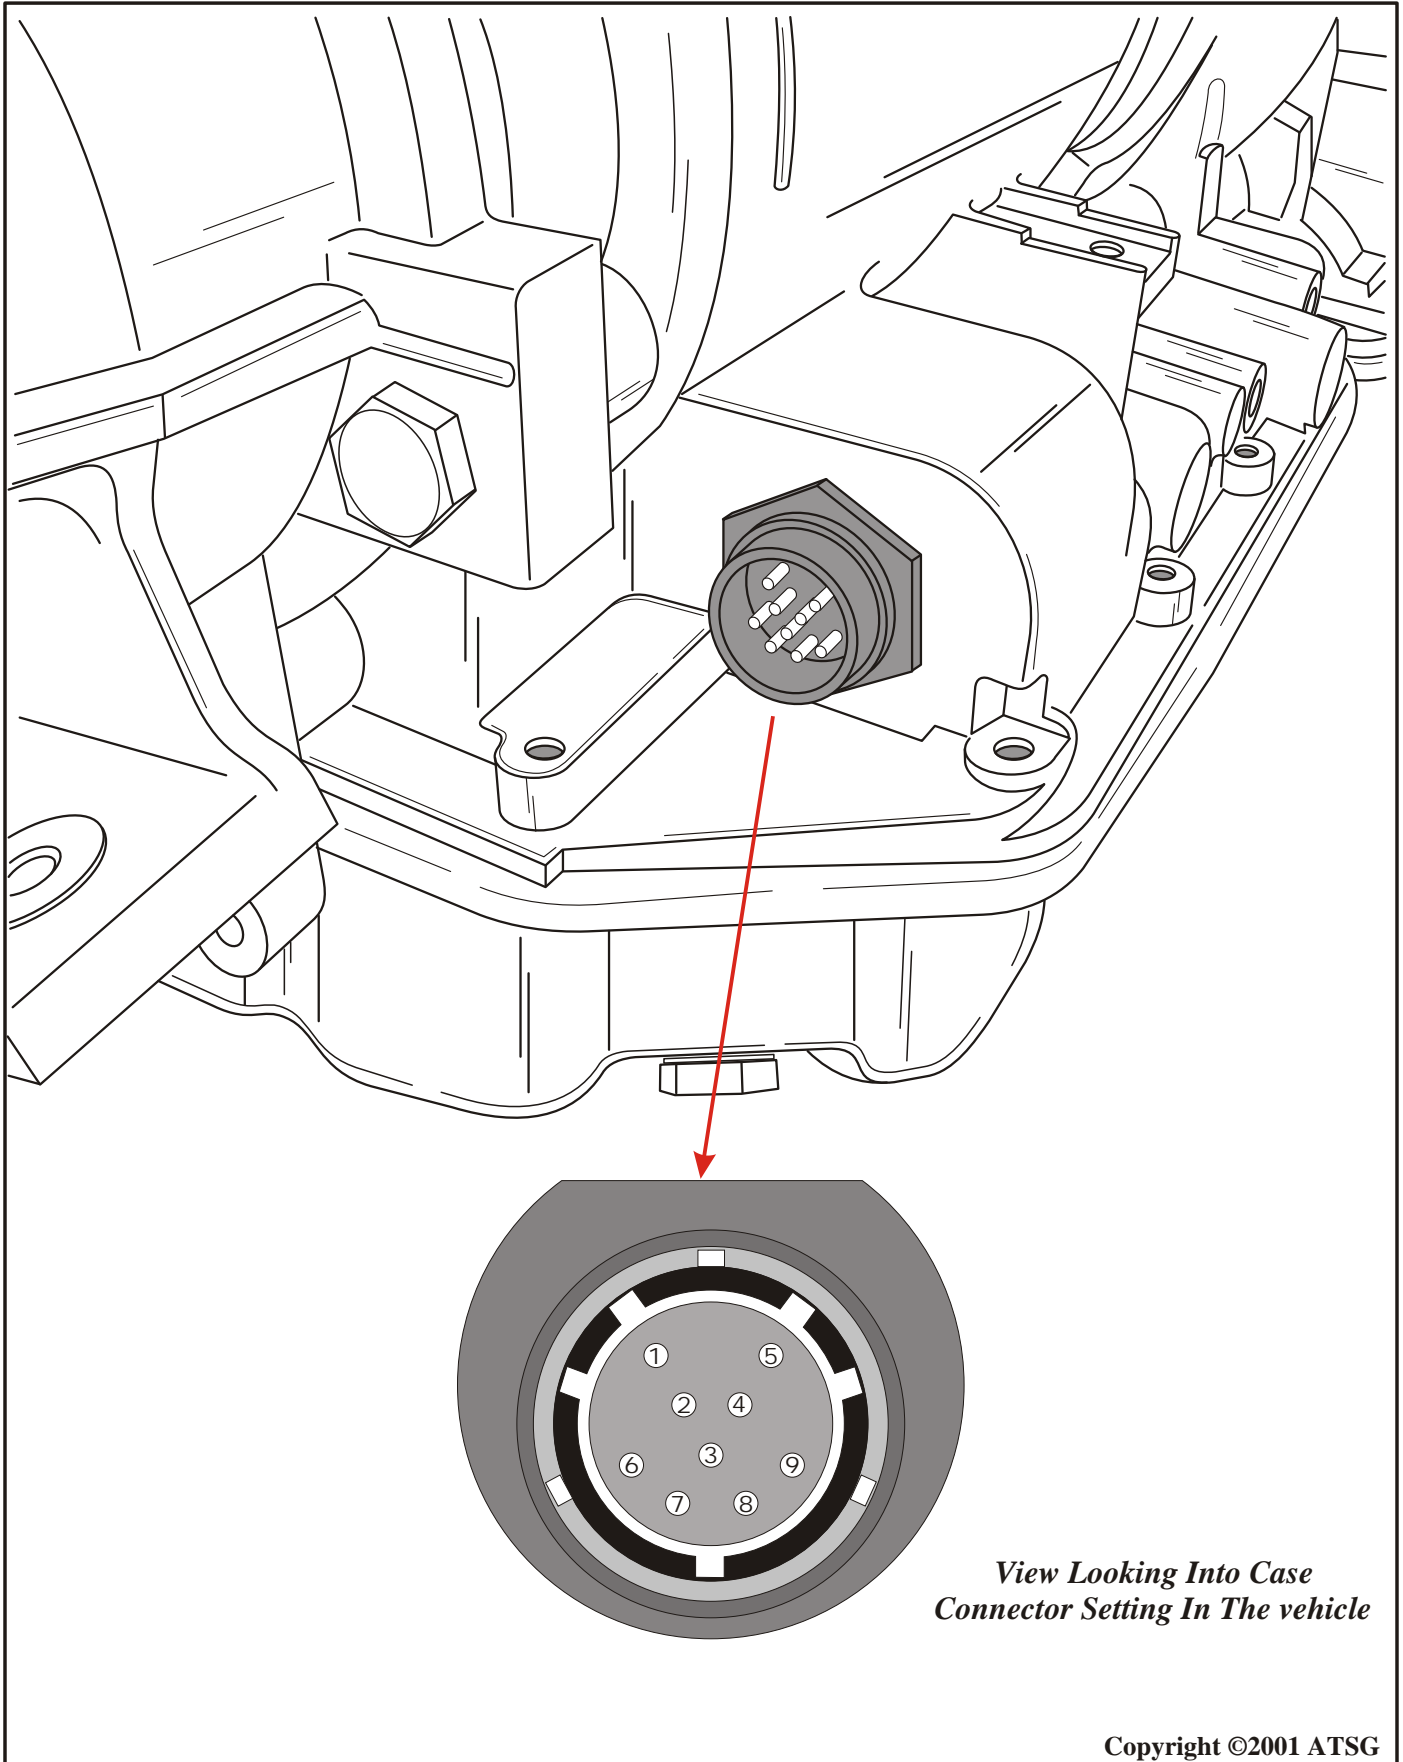
Figure 3

Turn ignition to the OFF position. Using a DVOM set to ohms, check the pressure control solenoid circuit between terminals 40 and 41 at the TCM. Solenoid resistance should be 2 to 6 ohms. If solenoid resistance is out of range, unplug the transmission case connector (See Figure 3), and recheck the pressure control solenoid resistance between terminals 1 and 3 (See Figure 4). If the resistance is still out of range, an inspection of the internal harness and solenoid will need to be performed and repaired. If the resistance is within range from the case connector but does not check correctly at the TCM, wires 40 and 41 at the TCM to the transmission will need to be individually inspected and repaired. If code 40 persists after all previous checks and necessary repairs have been made, continue on to step 3.

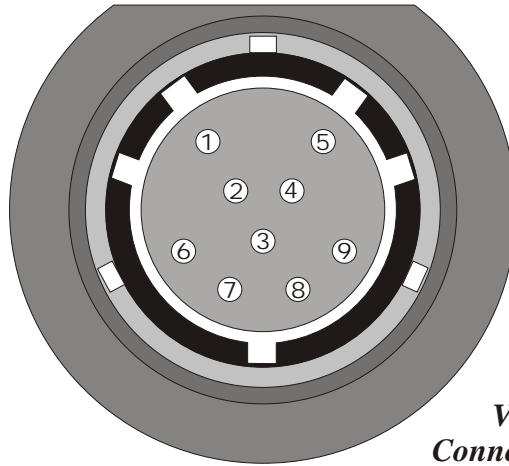
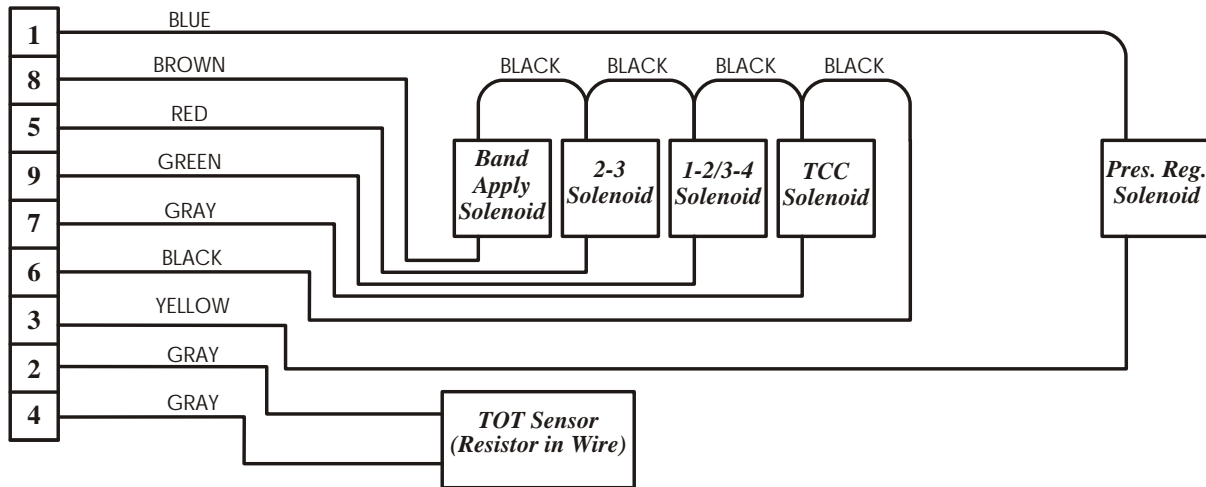
Figure 4

Solenoid	Case Connector	Resistance In Ohms
	Pin Numbers - +	
Band Apply	6 and 8	9.5 - 10.5
2-3 Sol.	6 and 5	17.5 - 18.5
1-2/3-4 Sol.	6 and 9	17.5 - 18.5
TCC	6 and 7	17.5 - 18.5
Press. Sol.	1 and 3	3.7 - 4.7
TOT	2 and 4	20K @ 70°F
