## BMW ZF-5HP-18 NO MOVE OR DELAYED ENGAGEMENT

**COMPLAINT:** Vehicles equipped with ZF-5HP-18 may exhibit a No movement, or a delayed engagement condition, before and/or after overhaul.

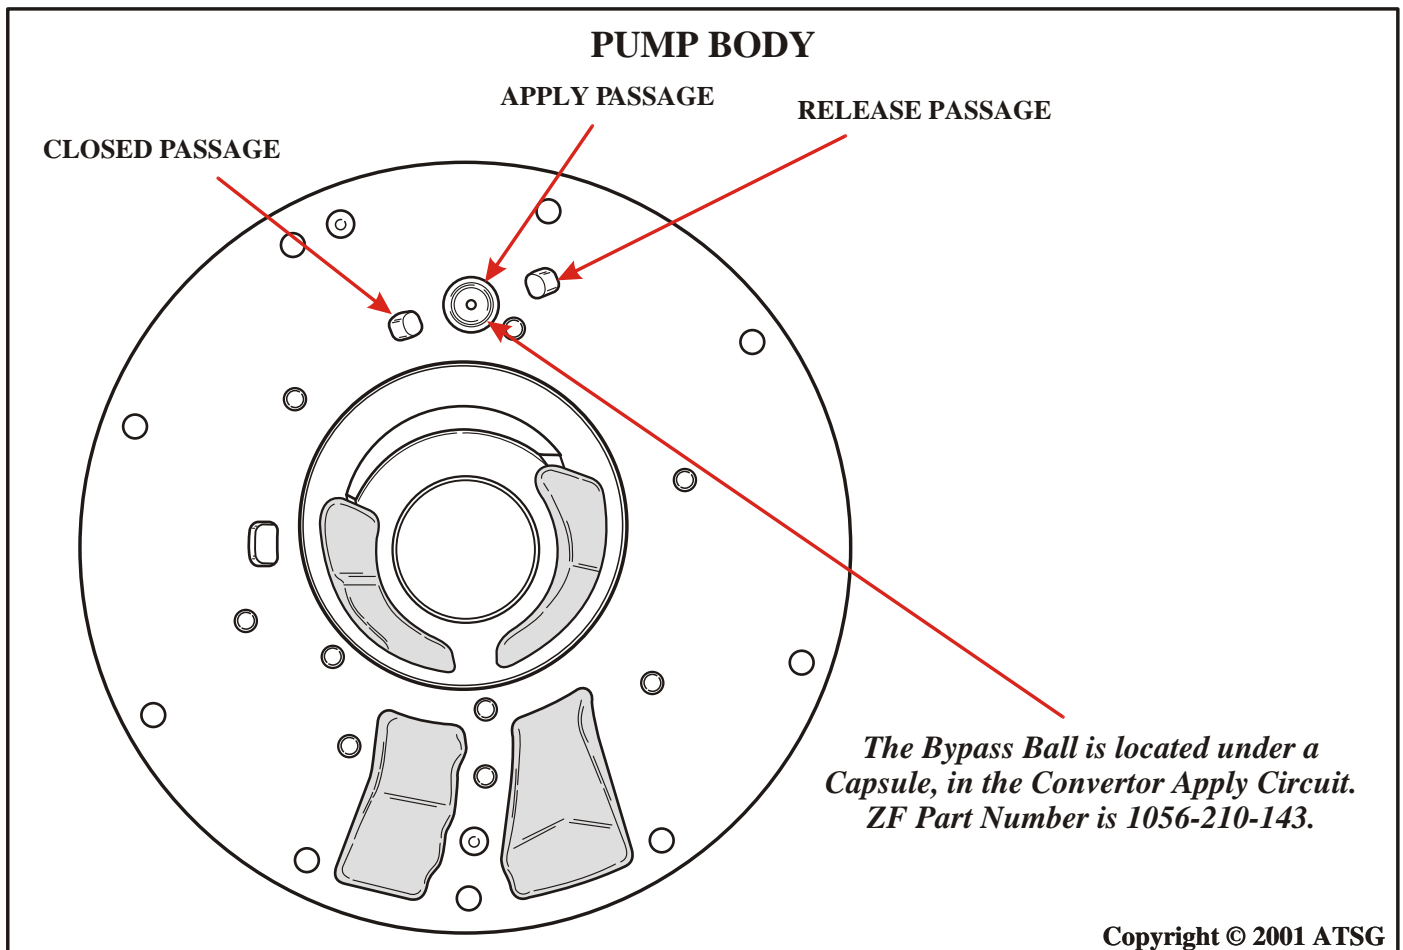
Figure 1

**CAUSE:** The cause may be, that the "Bypass Ball," located in the pump as shown in Figure 1, may have shrunken down and traveled back through the pump passage leading to the Torque Converter Valve, sticking the valve in the "stroked" position (See Figure 2). When this valve is stuck in this position it may cause the Torque Converter to drain-back after sitting for a prolonged period of time. When the vehicle is started after sitting, it may take 10 to 15 minutes for the Torque Converter to fill back up, and this all depends on the positioning of the stuck Torque Converter Valve.

**CORRECTION:** Locate the Torque Converter Valve, as shown in Figure 3 , and free the valve up, removing the shrunken Bypass Ball from binding the valves movement. Replace the assembly in pump body with a new one from ZF, available under ZF part number 1056-210-143, if the capsule can be removed from the pump body (See Figure 1).

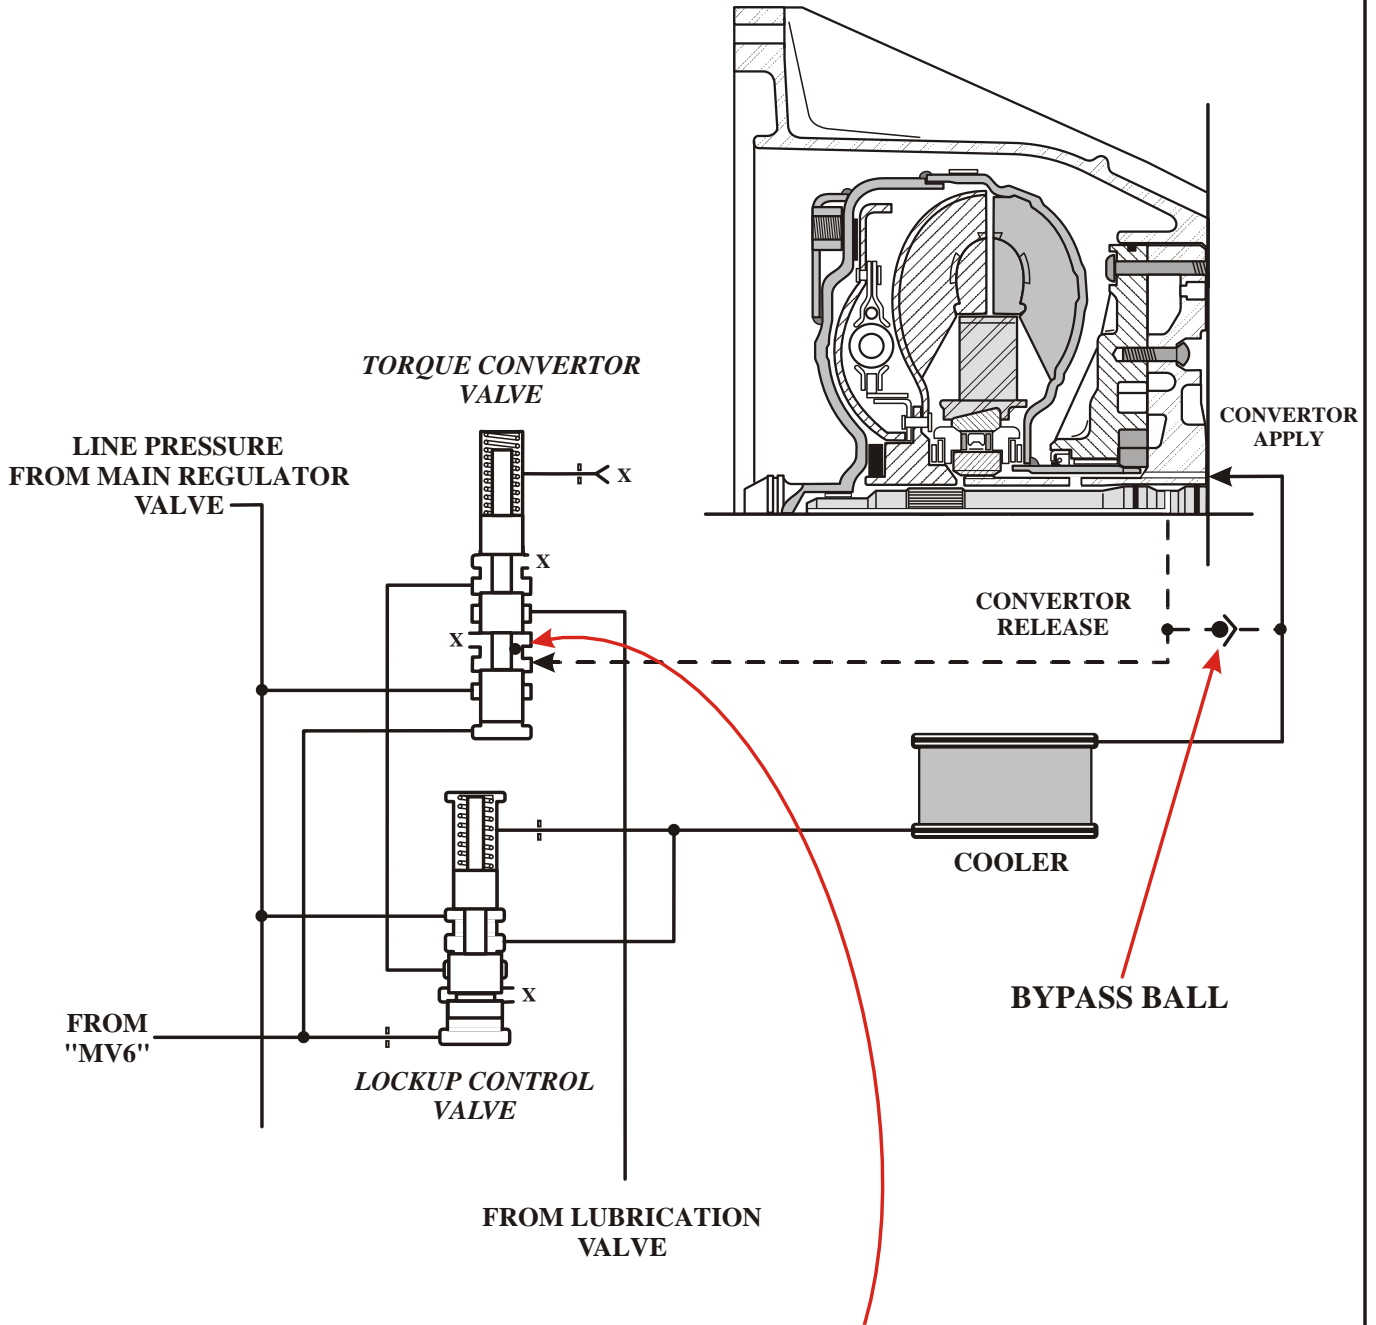
Figure 2

*The "Bypass Ball" shrinks and travels back through to the Torque Converter Valve and lodges itself in this passage, sticking the valve in this approximate position.*
