ZF4HP22

EXTREMELY HARSH SHIFTS

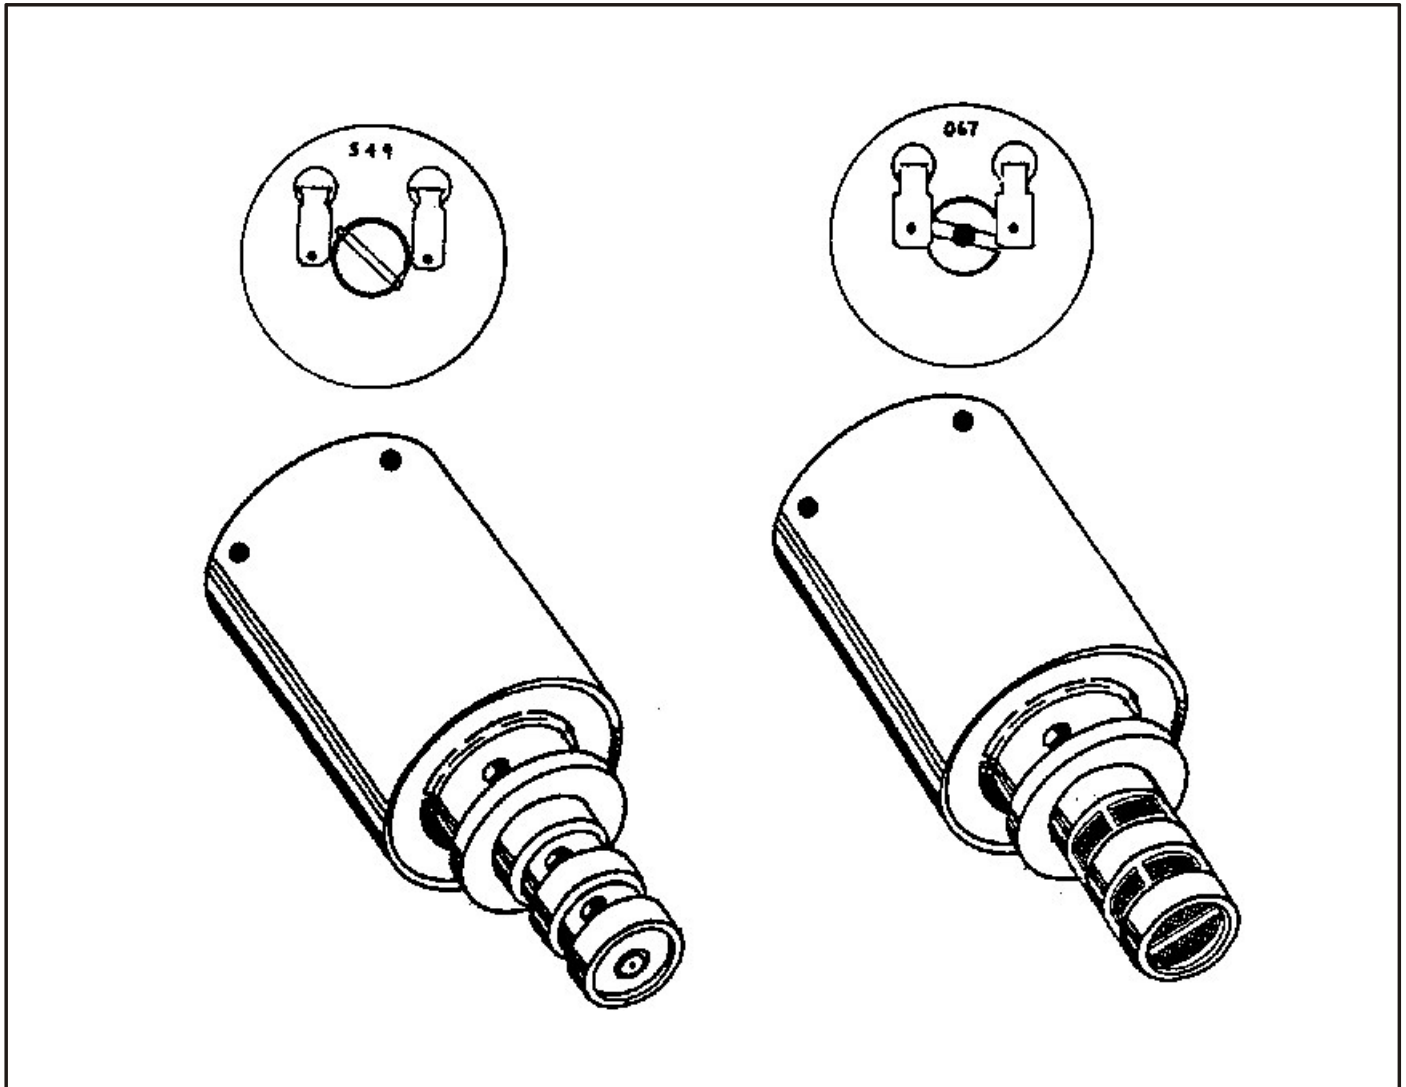
Figure 2

The BMW Pressure Regulator on the left uses no screens. The G.M. 4L80-E Force Motor on the right has screened ports and a steel ball pressed into the screw head to prevent tampering.
