## BMW ZF-5HP-18 "BIND-UP" WITH SELECTOR IN MANUAL "2" POSITION, 1st GEAR

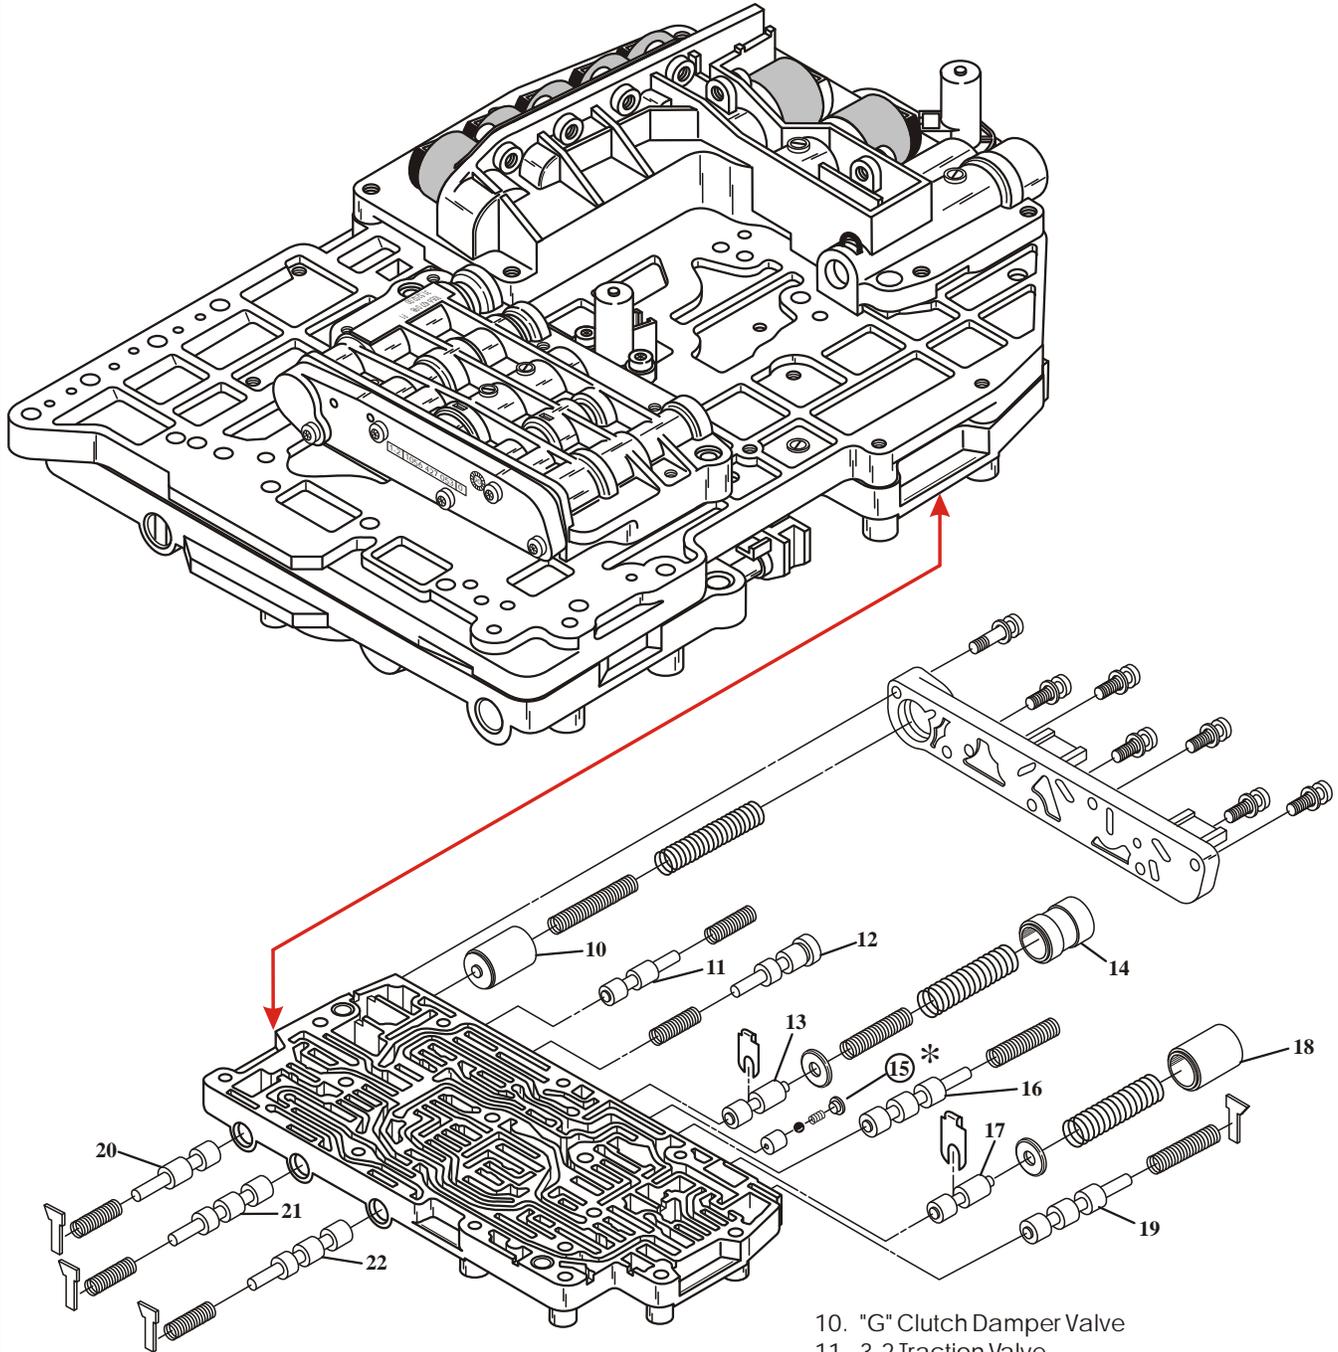
Figure 2

**CAUSE:** The cause may be, the plastic "D" Clutch One-way Check Valve assembly located in the Lower Rear valve body, shown in Figure 2, may be broken allowing the "B" Clutch (Reverse Input Clutch) to be on while the "D" Clutch (Low/Reverse Clutch) is on in 1st gear.
